Catheter Fracture and Cardiac Migration - An Unusual Fracture Site of Totally Implantable Venous Devices: Report of Two Cases

Key words: catheter fracture, totally implantable venous devices, pinch-off sign.

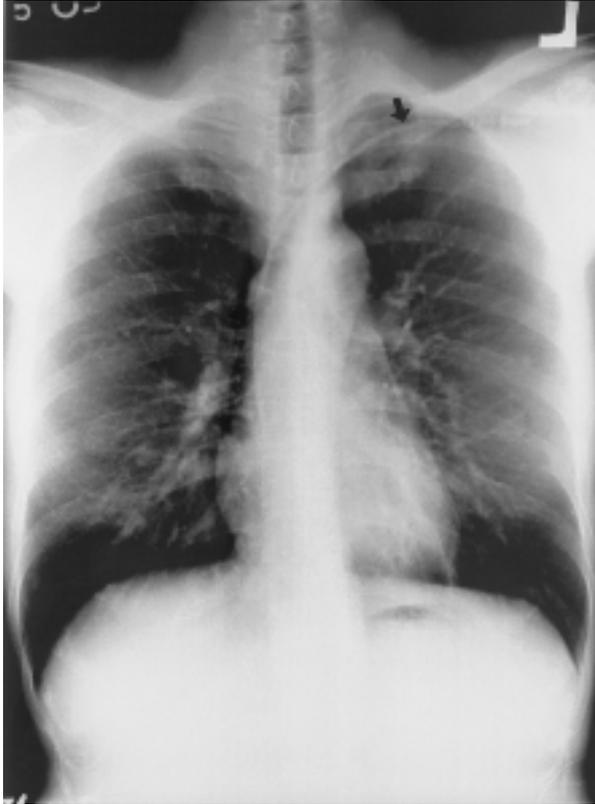
Fig. 1 Satisfactory placement of the port-a-cath system and the usual site for the pinch-off sign (arrow).

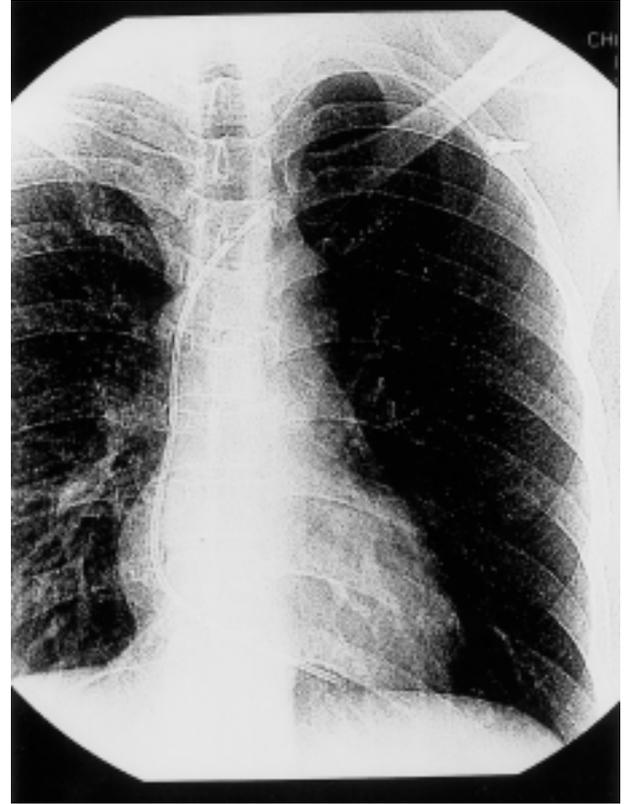
In March 2001, about 15 months after the initial implantation, the annual follow-up chest radiograph showed the injection port chamber was at its original position but the catheter had fractured and embolized in the right side of the heart (Fig. 2). The fracture site was just at the junction of the injection port chamber and the catheter.

Fig. 2 Chest radiograph showing fractured catheter in the right side of the heart.

Surgically, we implanted a port-a-cath system via the left cephalic vein using the open cut-down technique, which practically ruled out the catheter pinch-off. We connected the port system and the catheter gently to prevent catheter trauma. The injection port chamber was anchored to the underlying pectoral muscle fascia with 2-3 prolene sutures and totally implanted in subcutaneous tissue. A test puncture was carried out to check patency and flow through the system before and after the reservoir implantation. Each patient received a chest radiograph immediately after implantation to check the catheter position and identify potential complications such as catheter neck kinking or tip migration to the internal jugular or contralateral subclavian veins. Because of improper anchoring of the fixation site near the deltopectoral groove, the catheter was vul-

nerable to compression between the fixed injection port chamber and the movable catheter with shoulder movements. As a result, catheter pinch-off preceded and the fracture followed.

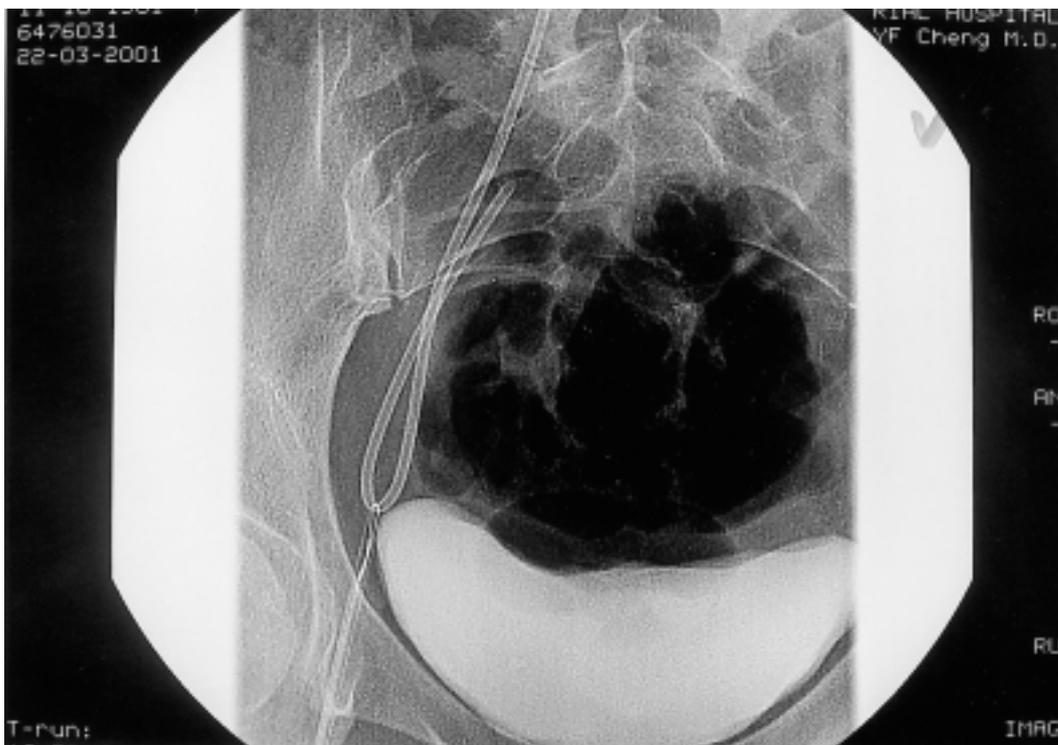
A percutaneous procedure was carried out via a right femoral vein puncture. Selective catheterization of the right side of the heart via the inferior vena cava was achieved using the loop-snare technique (Fig. 3). The fractured catheter was engaged and removed through the femoral vein. The injection port system was removed under local anesthesia without any complications (Fig. 4).

Fig. 3 Percutaneous retrieval of fractured catheter by a radiologist.

Once a catheter fracture has occurred, the fragment should be removed as soon as possible. Subsequent embolization to the right side of the heart or pulmonary artery may result in life-threatening dysrhythmias.⁽¹¹⁾ To avoid open surgery, the percutaneous retrieval technique is preferred because it is simple, inexpensive and relatively low risk.

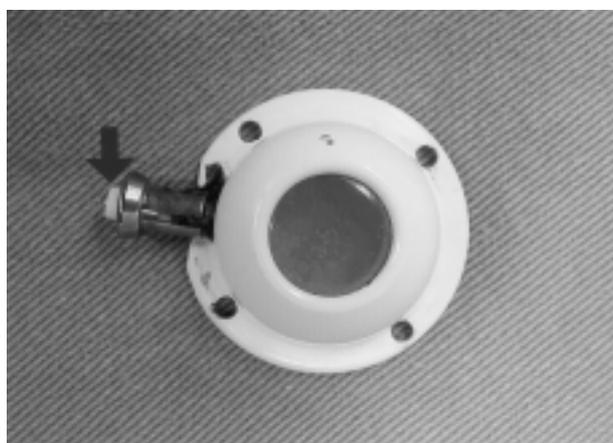
Fig. 4 Injection port chamber with fractured catheter (arrow).

The management of catheter fractures includes both prevention and early detection measures. Surgical techniques are important in prevention. As suggested by Cassidy et al,⁽¹²⁾ the approach using subclavian vein by puncture should be lateral to the midclavicular line. The routine used during open cut-down technique for implantation has the advantage that iatrogenic pneumothorax and catheter pinch-off are practically ruled out.⁽¹⁾ Moreover, the injection port chamber should be placed far from shoulder joint and never across the deltopectoral groove.
